## Brisbane Central Business District Bicycle User Group CBD BUG

I write to you on behalf of Brisbane Central Business District Bicycle User Group members to question the Howard Smith Wharves (HSW) redevelopment receiving 2020 Planning Institute of Australia awards in the categories of "Great Place Award" and "Hard Won Victory".

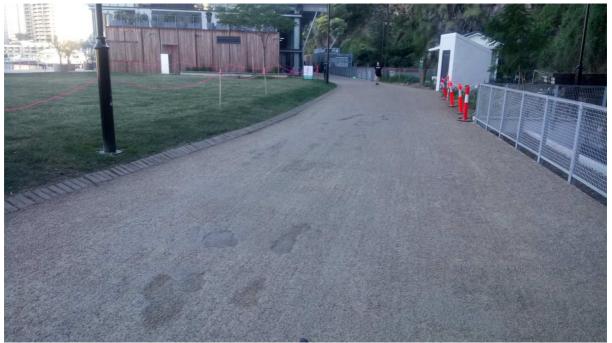
1. HSW constructed the main public easement (connecting to the New Farm Riverwalk) as an off-camber, loose gravel, shared path, which proved both hazardous to path users, and impossible to maintain (Figures 1,2,3). This path was finally replaced with a properly sealed surface in August 2019, after intense lobbying from active transport groups (Figure 4).

Figure 2 - Potholes in active transport corridor surface

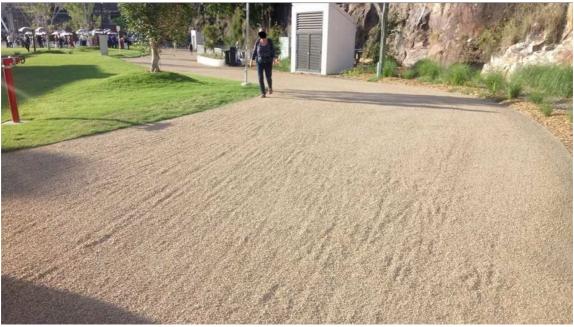
Figure 3 – Loose gravel surface of active transport corridor

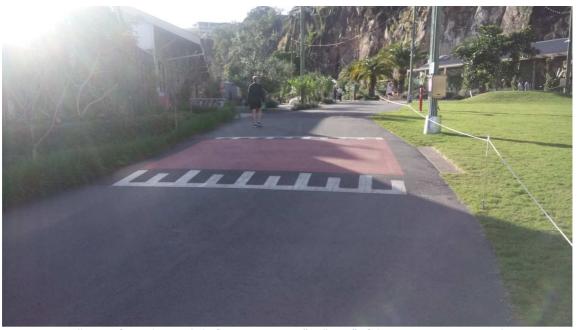
- d. even the re-constructed (sealed) path appears not comply with DDA legislation with the installation of a speed control platform on a 1 in 21 walkway. (Figure 9).

Figure 9 – installation of speed control platform on a 1 in 21 "walkway" of the active transport corridor

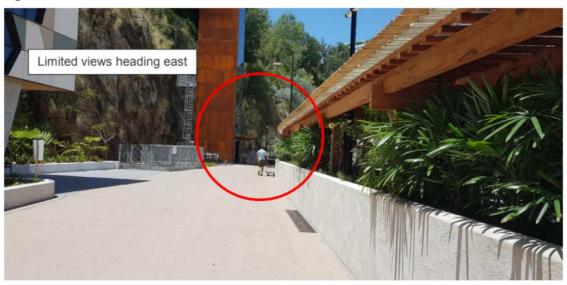
Picture 1 – View looking east

- 4. HSW, in modifying the originally approved landscape plans (Dec 2015) to move the lift door location and expand the beer garden, created a queueing and sight-line issue between the shared path, the cliffs lift, and the exit from the beer garden. This has created an unpleasant and hazardous situation for both patrons and path-users, which was acknowledged by Urbis soon after opening (Figure 10). It is noted that the mitigations proposed in that Urbis report were either not implemented (cutting back the foliage), or implemented poorly (adding signage), and as such the issue remains unresolved to this day.

Figure 10 – Documentation of poor sight lines at critical junction (190214\_BCC Response to Further Issues, Urbis 2019)

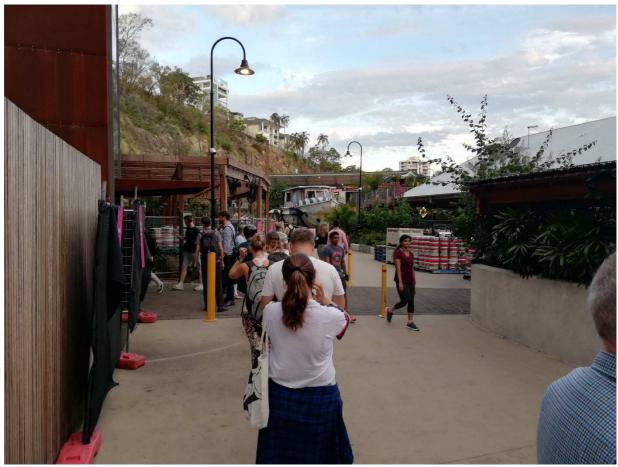
- 5. In September 2019, HSW installed small, low-height bollards at this conflict location (Figure 11), presumably as a means of "slowing" path users. However, this type of treatment is known to be hazardous to cyclists, even at relatively low speeds, and is not recommended as a means of slowing cyclists in the AustRoads guidelines. Such a band-aid fix is a clear indication that the design at this location is fundamentally flawed, despite the developer having abundant space in which to design a safe and pleasant crossing.

Figure 11 – The crowded lift access, with hazardous low bollards and unapproved structures in background

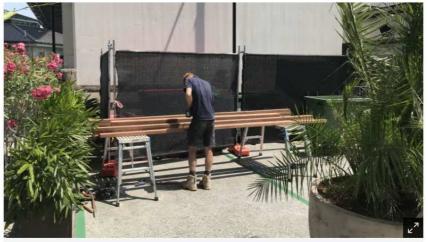
- 6. HSW has constructed extra drinking and dining areas in close proximity to this conflict location, this not only added to the traffic and hazards at this location but failed to seek Council planning approval for the works (Figure 12).

Some of the building work at Howard Smith Wharves that's being questioned by Brisbane City Council. This space is zoned as a set-down area, according to planners. TONY MOORE

Figure 12: news article regarding unapproved buildings and extensions on site

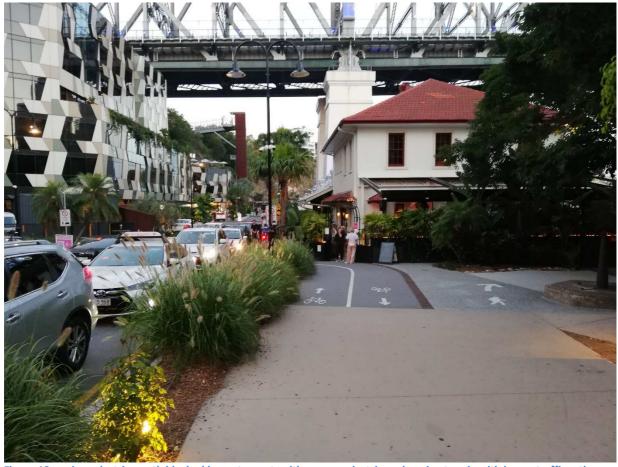
- 8. HSW has allowed the northern-most tenancy to fence-off and construct a dining area over the top of the designated pedestrian pathway, which was to provide the main access between the development and the CBD. Despite bold pavement markings directing pedestrians to the riveredge boardwalk, the clear desire line results in the majority of path users crowding the already-narrow dedicated bicycle path and walking directly into traffic on the main driveway, while restaurant patrons queue across the dedicated bicycle path (Figure 13). It is clear the restaurant was constructed without consideration or forethought for path users & is evidenced by the relocation of decorative buoy previously blocking access to the riveredge boardwalk path, (Figure 14).

Figure 13: main pedestrian path blocked by restaurant, with many pedestrians choosing to mix with heavy traffic rather than take detour to the right

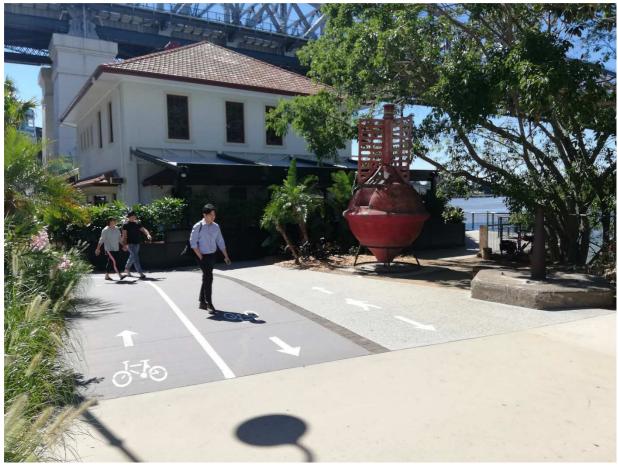
Figure 14: main pedestrian path completely blocked by restaurant to the left and buoy to the right

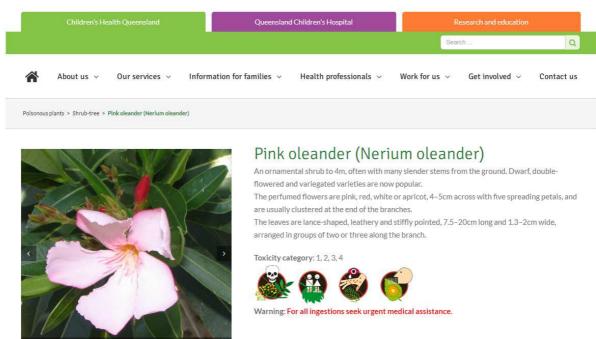
- 9. HSW has planted toxic shrubs along the active transport corridor that poses a hazard to children (Figure 15).

Figure 15: Queensland Health advice on Pink Oleander currently planted along HSW Active Transport Corridor

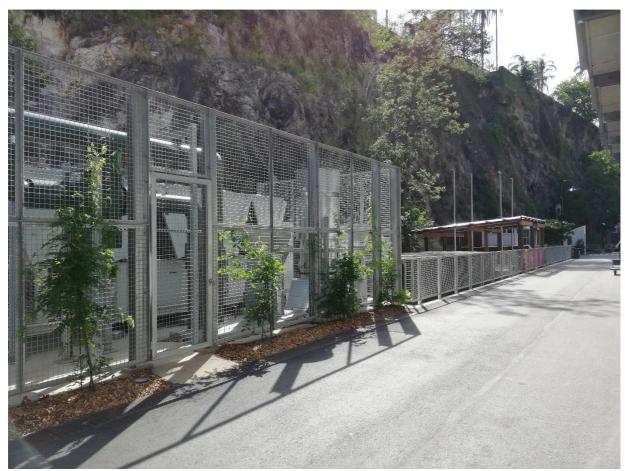
In addition to these issues impacting negatively on active transport users, other undesirable aspects from the community's perspective include the development not providing the amount of public open green space required by Council's approval, and the obstructing of public access to the heritage register-listed bomb shelters located at the rear of this site (contrary to the developers claims, these bunkers have simply been hidden out of the way, and out of sight, near unsightly equipment and machinery, Figure 16).

Figure 15: Heritage listed bunkers are hidden away near unsighly equipment
