File number:  
2020/2713  
Deceased name:  
Carolyn Anne Lister

### **Coroner's findings and notice of completion of coronial investigation**

Carolyn Anne Lister

On 30 June 2020, Carolyn died instantly as the result of a crash between her bicycle and a large tip truck, near the intersection of O'Connell Terrace and Bowen Bridge Road, opposite the RWBH at Herston, Brisbane in Queensland.

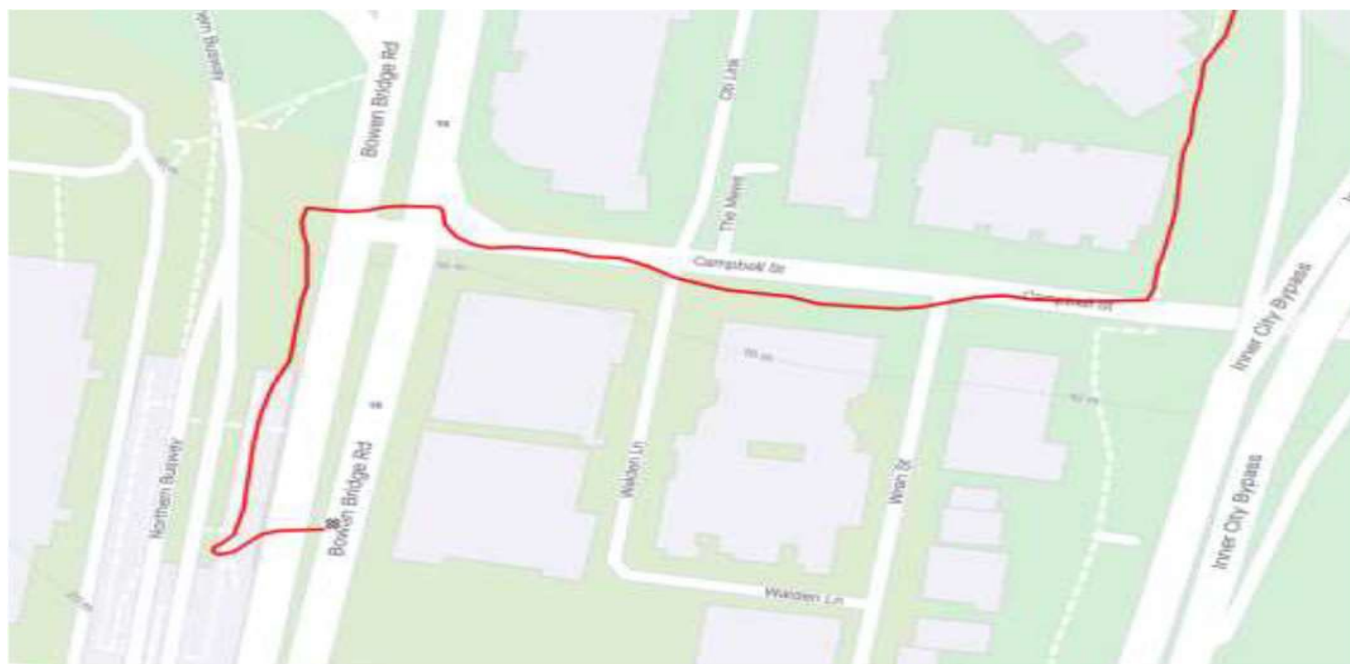
Usual route(O'Connell Tce is just off the bottom of the map)<sup>1</sup>

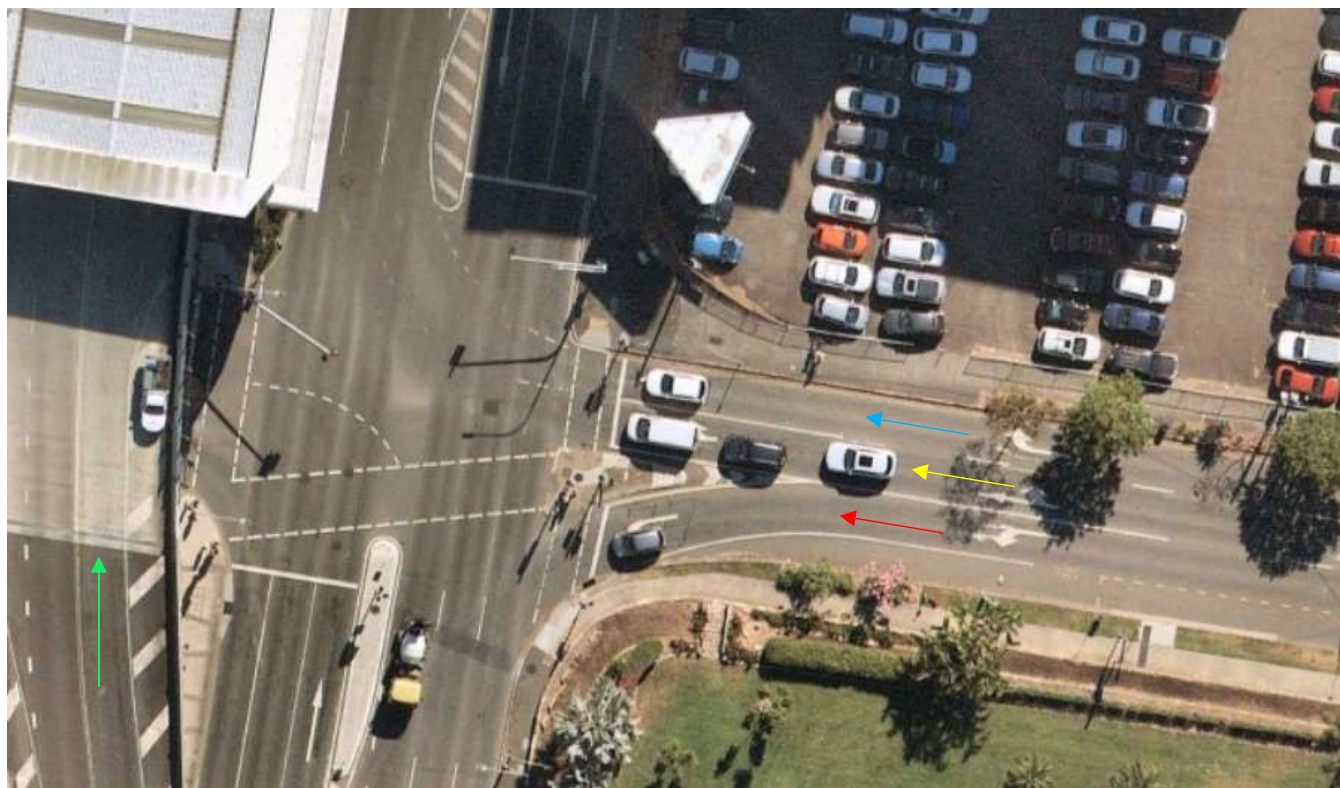
*Near Map image of the intersection. The red arrow indicates the dedicated left turn lane, the yellow arrow the right turn/straight ahead lane and the blue arrow the right turn lane. The hospital carpark can be seen at the top right of the photographs. The road on the left of the photograph indicated by the green arrow is the busway flyover<sup>2</sup>.*
