## Brisbane Central Business District Bicycle User Group

The CBD Bicycle User Group (CBD BUG) is writing to you regarding the lack of progress on making the CityLink Cycleway lanes permanent and the current poor condition of these lanes.

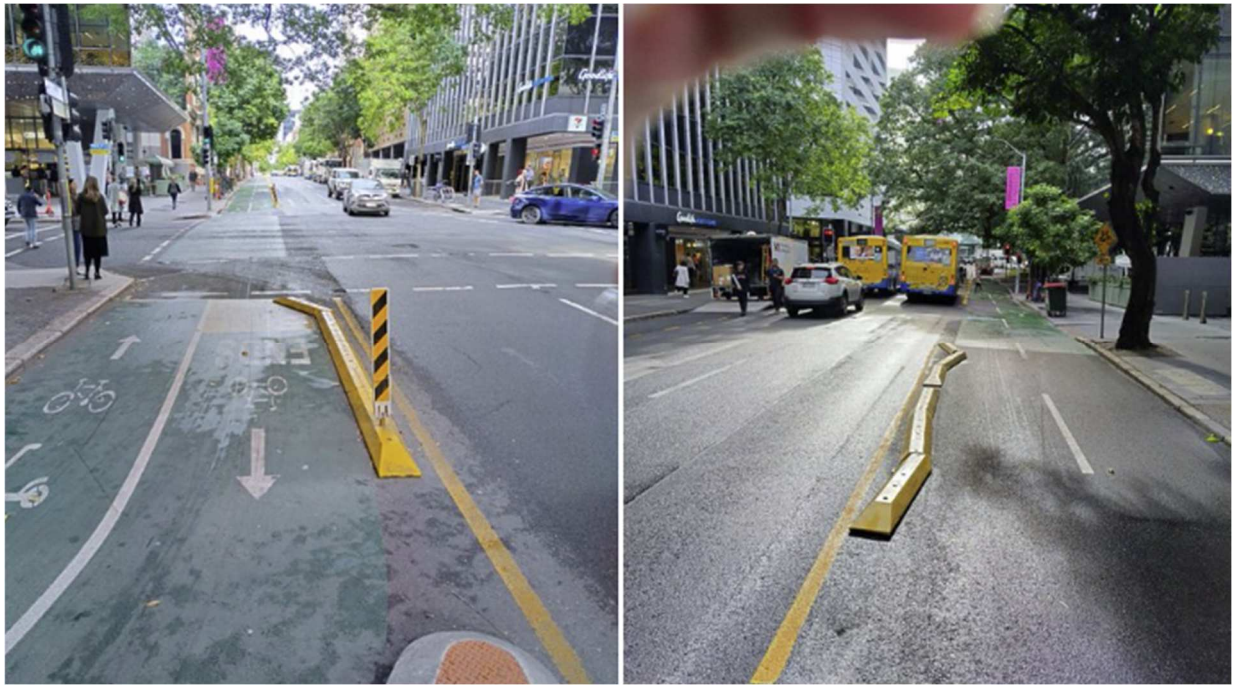
As previously stated, the CBD BUG supported the installation of simple plastic barriers as a method to quickly provide low-cost, safe, protected bike lanes. Plastic barriers were an entirely appropriate approach for trialing an installation; however, after two years the temporary nature of these barriers was beginning to show. They are frequently dislodged due to vehicle impact (Figure 1). In November 2022 Cr Murphy stated the lanes would be made permanent "slowly". While we understand this sentiment, it has now been four years since the barriers were installed, and they incur a maintenance cost which could be reallocated to permanent barriers. Accordingly, we would appreciate Council's advice about the timeframe for these barriers to be made of a permanent construction method.

Figure 1 – dislodged dividers

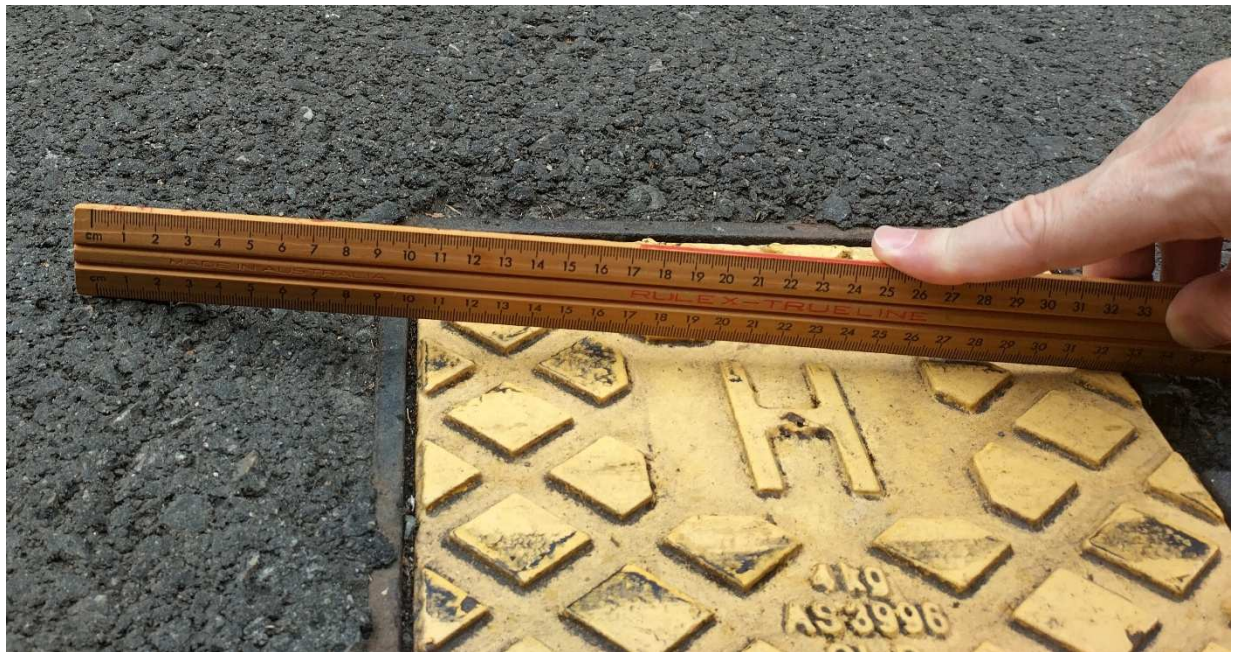
In our previous letter to Cr Murphy in 2023 we raised this matter, but the uneven surface of the Elizabeth St bike lane continues to be a safety issue. While the works by Urban Utilities have been completed, the bike lane surface has been left in a deplorably rough/uneven condition and is therefore unsafe for users. The asphalt is not flush with any of the inground service points resulting in an unsafe cycling/scooting surface (Figures 2 & 3). A copy of this letter has also been sent to Urban Utilities for their attention, although given their failure to address this issue and another relating to public safety, the CBD BUG have doubts they will act to address the safety defects they left behind on this cycleway unless, Council also applies substantial pressure.

Figure 2 – fire hydrant cap uneven with road surface

The CBD BUG would like to enquire why Brisbane City Council did not ensure that Urban Utilities reinstated the CityLink Cycleway surface to the previous quality that allowed for safe travel along the bike lanes. If Urban Utilities will not reinstate the lanes to their previously undamaged state, we call on BCC to resurface this lane to its former good quality level of service and safety. We recommend that this resurfacing be delivered as part of the project making these lanes permanent.

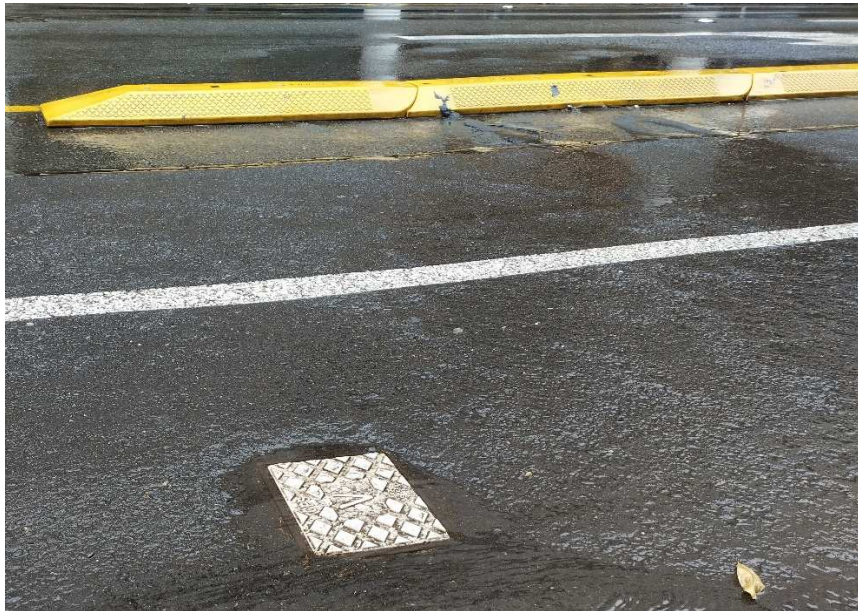
Figure 3 – water pooling in uneven surface

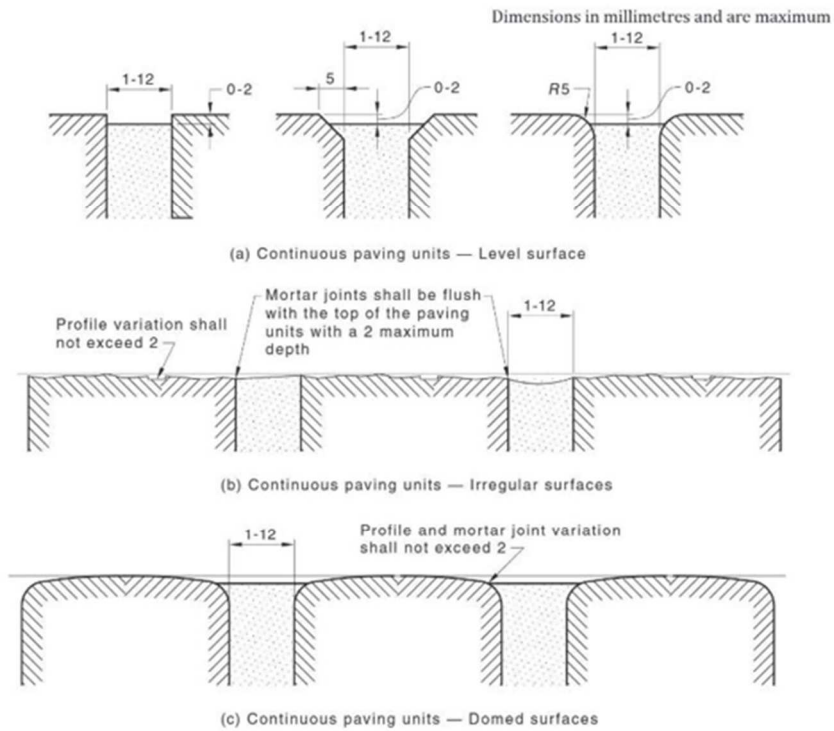
Figure 6

The most pressing of these from a safety perspective is the cycleway's crossing of Eagle St at Fig Tree Reserve. Even before the installation of CityLink this pedestrian crossing was at capacity and needed a reduction in the width of the road surface to be traversed, increases in the width of the kerb ramps and the installation of widened footpaths (on the reserve itself). These changes are necessary given that the current kerb ramps and surface material on the reserve side of this crossing appear to be non-compliant with the Australian Standard for disability access AS1428.1. (Figure 5,6&7).

Accordingly, the CBD BUG would like to enquire if there has been any design work to align this crossing with the above parameters and if/when these corrective works might occur?

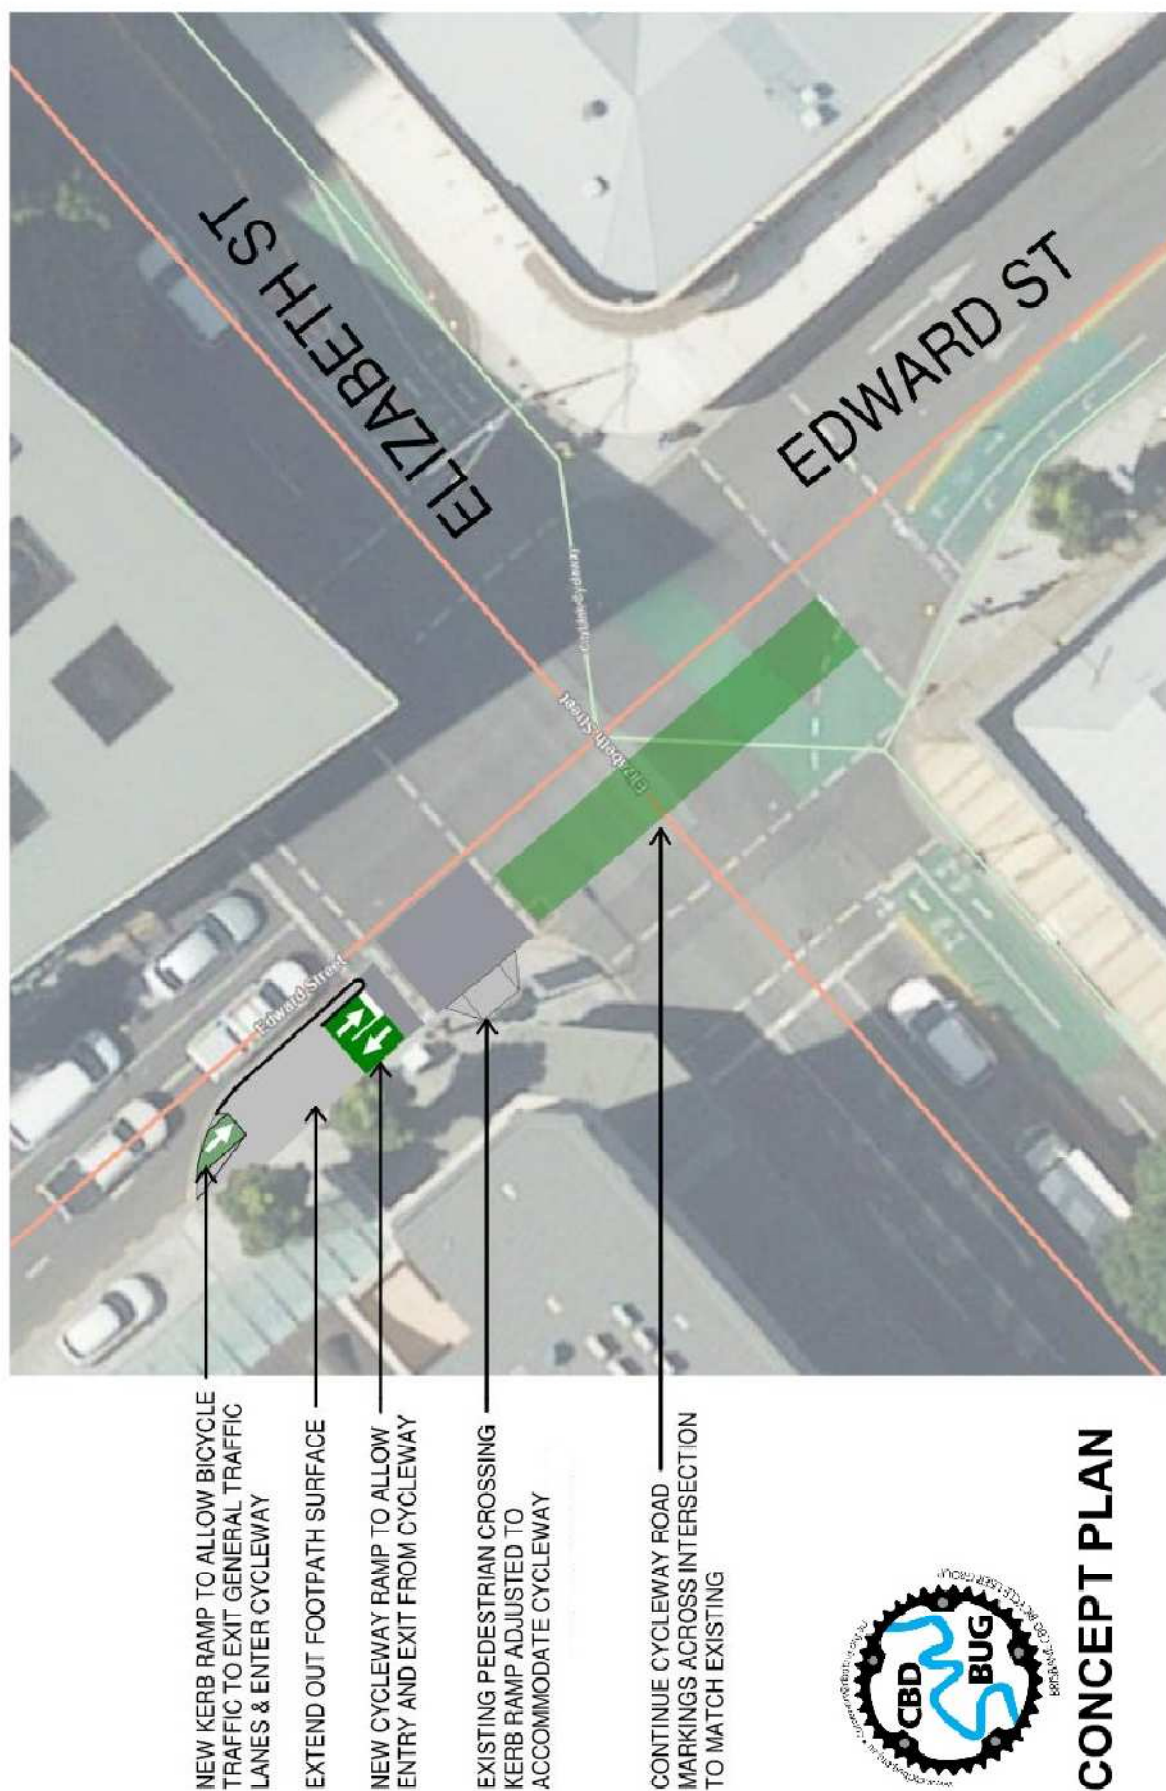
Figure 8

Accessing and egressing from the Edward St Cycleway lanes is dangerous. Riders exiting the lane and continuing along Edward St must merge into the pedestrian crossing. This creates a capacity issue due to high pedestrian numbers. Riders travelling along Edward St on road wishing to enter the Edward St cycleway lanes have no clear way to enter these lanes.

We ask that the lanes continue across the intersection, similar to Figure 8. This will result in a clearer and safer situation for all active transport users at this location.
