Brisbane Central Business District Bicycle User Group CBD BUG

This letter is in relation to the inappropriate design of the new intersection of the Brisbane City Council off-road bikepath that runs north-south through Coorparoo where it crosses Morley Street.

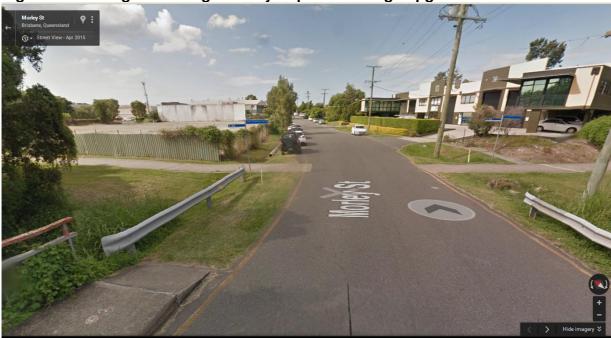
Figure 1: Looking east along Moreley St prior to bridge upgrade

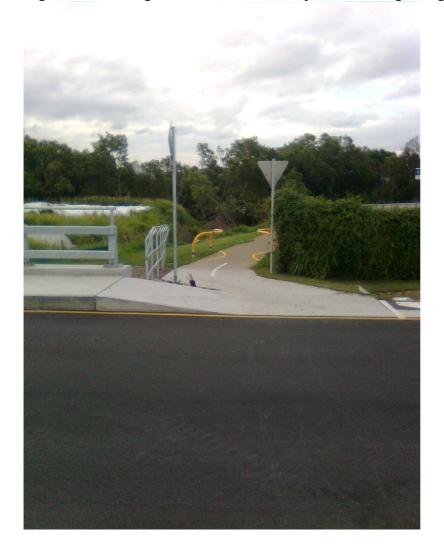
- By its close proximity to the bikepath entrance the eastern ramp from the new bridge's north side pedestrian path to the ground level now creates a hazard for cyclists entering/exiting the bikepath who are not aware and / or who do not realise this ramp is in this position. This ramp is viewed as particularly hazardous for cyclists riding north across Morley Street as they are likely to run into the vertical side of this ramp in mistakenly assuming that the path goes straight across the road on the line of the visible path as it did prior to this new bridge being installed. This is most clearly evident from the attached Figure 2.
