CBD BUG

**Brisbane Central Business District Bicycle User Group (CBD BUG) submission re
Development Application: A006099651 - 3 Boundary St Brisbane City Qld 4000**

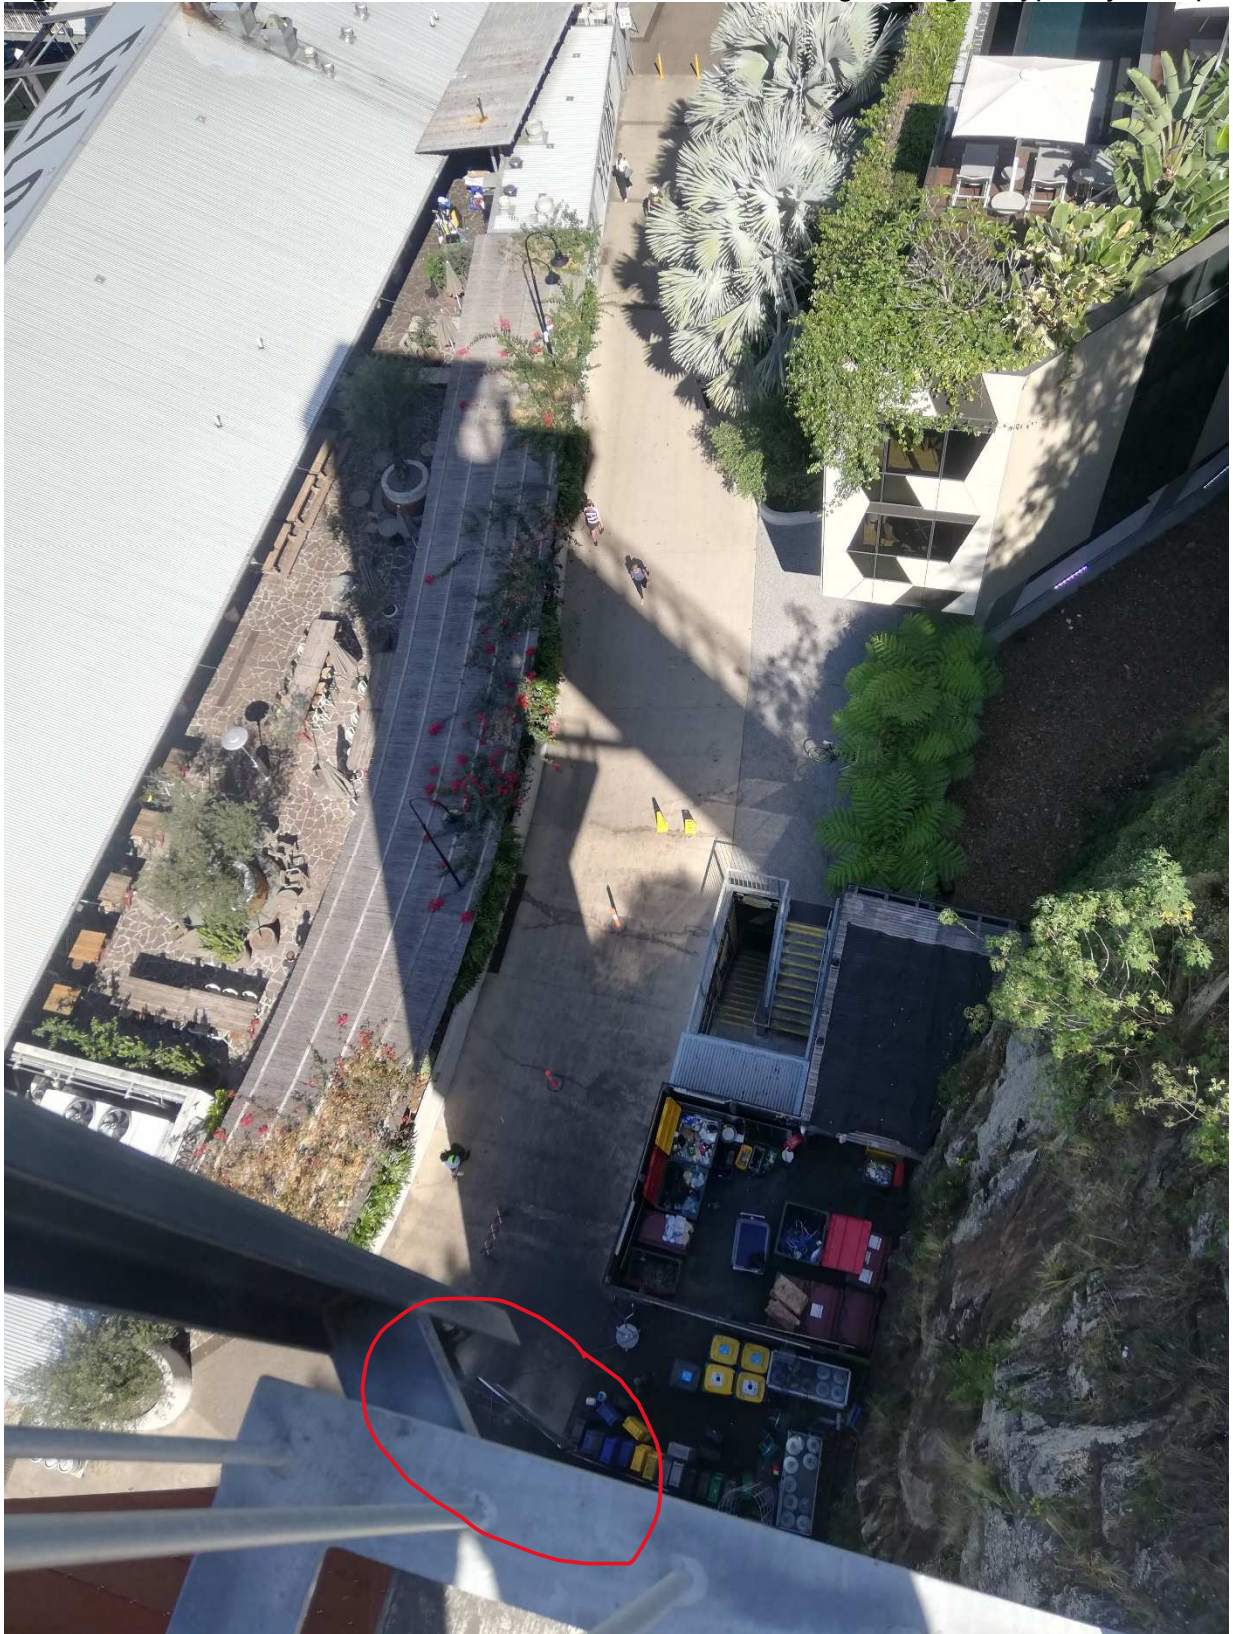
Furthermore, since the redevelopment of the HSW precinct the developer has displayed a neglect, if not contempt, for the amenity and safety of the community members simply wanting to travel to or from the CBD via this site. Figures 1 to 3 at the end of this submission show just some of the instances of this routine behaviour. Sadly, this too has been allowed by a supine Brisbane City Council (BCC). While there are numerous examples of BCC's lax attitude in controlling development of this precinct, a key example is how key recommendations from Council's own engineering team on 15 October 2018 (in relation to DA A004897686) were almost completely ignored.

Figure 1: Overhead view of bollard hazard and informal storage with gate typically left open

The removal of the low bollards, which represent a hazard, and should not have been installed in the first place, is welcomed. The addition of the timber rail fence would also seem to represent a welcome safety improvement.

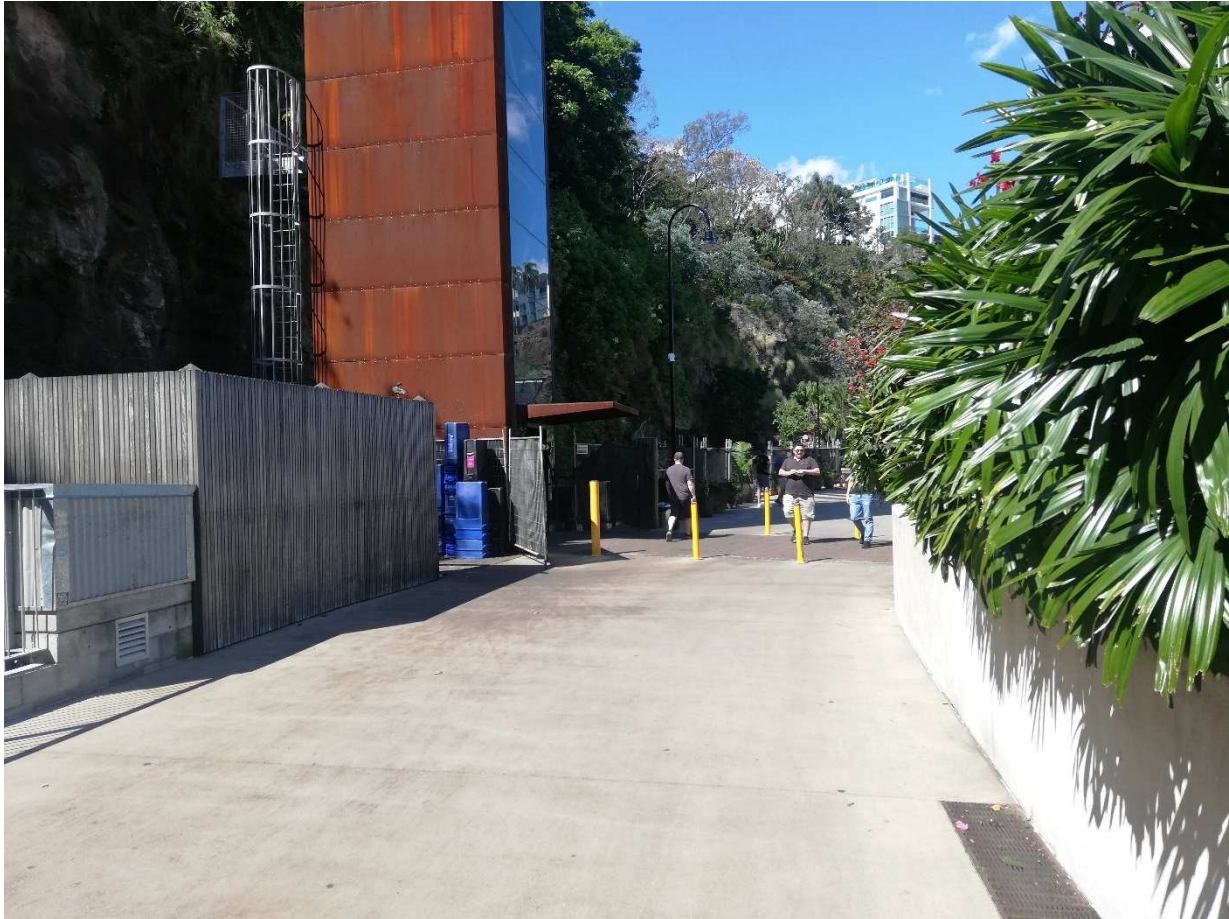
Figure 2: Ground level view of bollard hazard and informal storage with gate typically left open

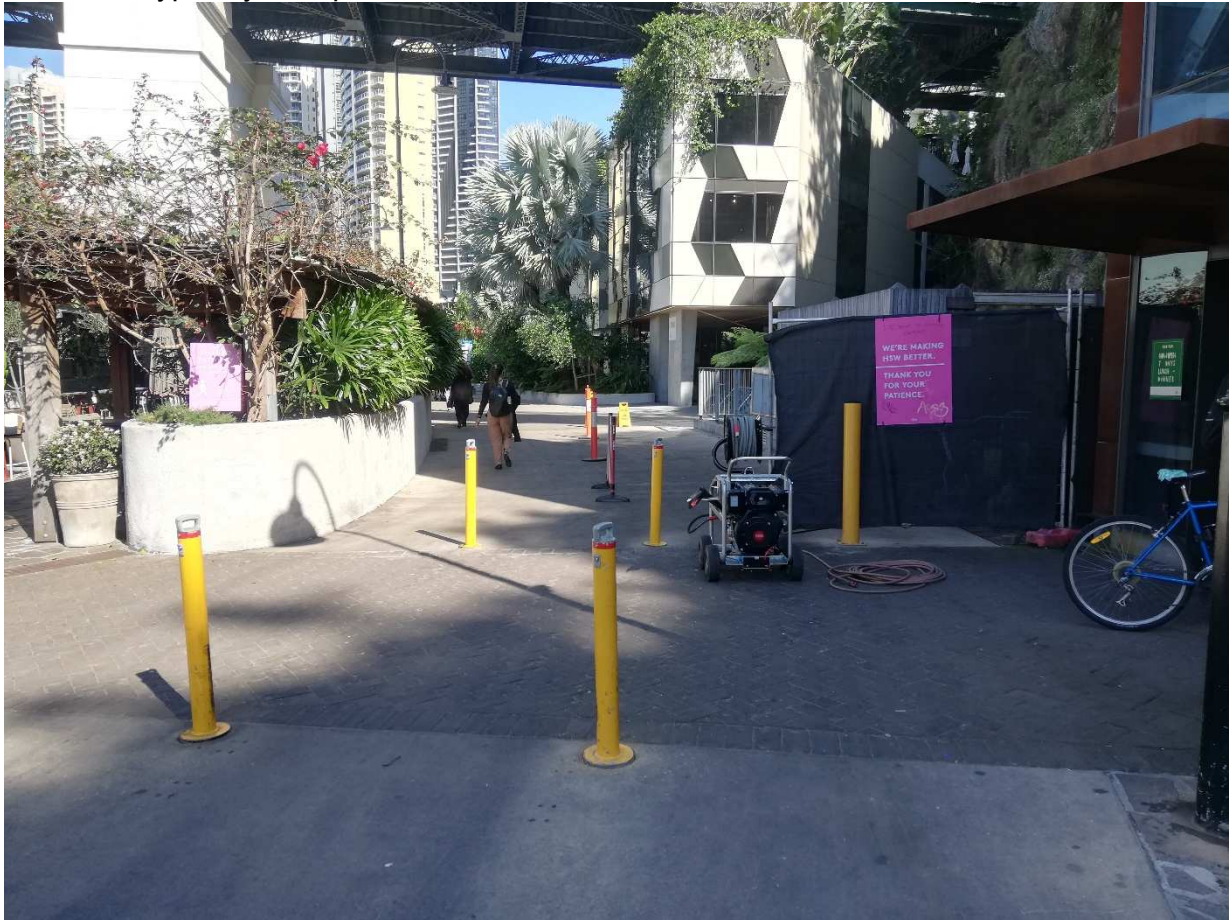
Figure 3: Ground level view of bollard and equipment hazards and informal storage with gate typically left open

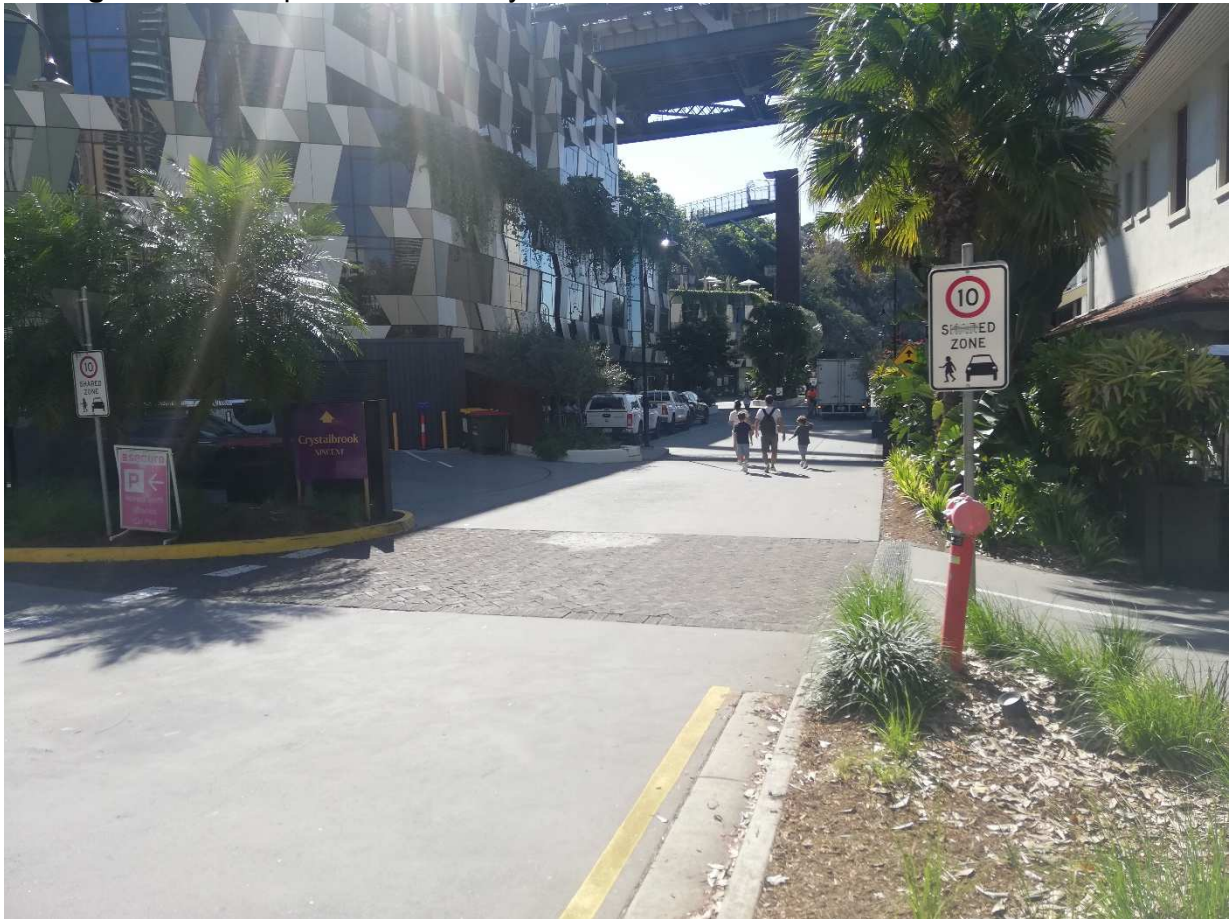
Under the current configuration, there is insufficient space for both 2-way motor vehicle traffic, and dedicated pedestrian space. Although such a shared space can work well when motorists and pedestrians cross paths for short distances, such a long stretch with motorists stuck behind people walking is not best practice - as it results in impatience from car drivers and discomfort for pedestrians. By either modifying some of the traffic islands at the pinch point (refer Figure 4 at the end of this submission), or moving the main drop-off area to the underground parking area, for example, this could be greatly improved.

Figure 4: Pinch point on driveway

At the minimum, the traffic engineering consultants should provide a formal assessment of this shared space, with respect to these issues, and the following recommendations by Council on 15 October 2018 (in relation to DA A004897686) should be reconsidered:

1. a "speed control platform" to reduce motor vehicle speeds where the bicycle rider traffic emerges out into the shared zone, and
2. a dashed centre line along the active transport corridor.

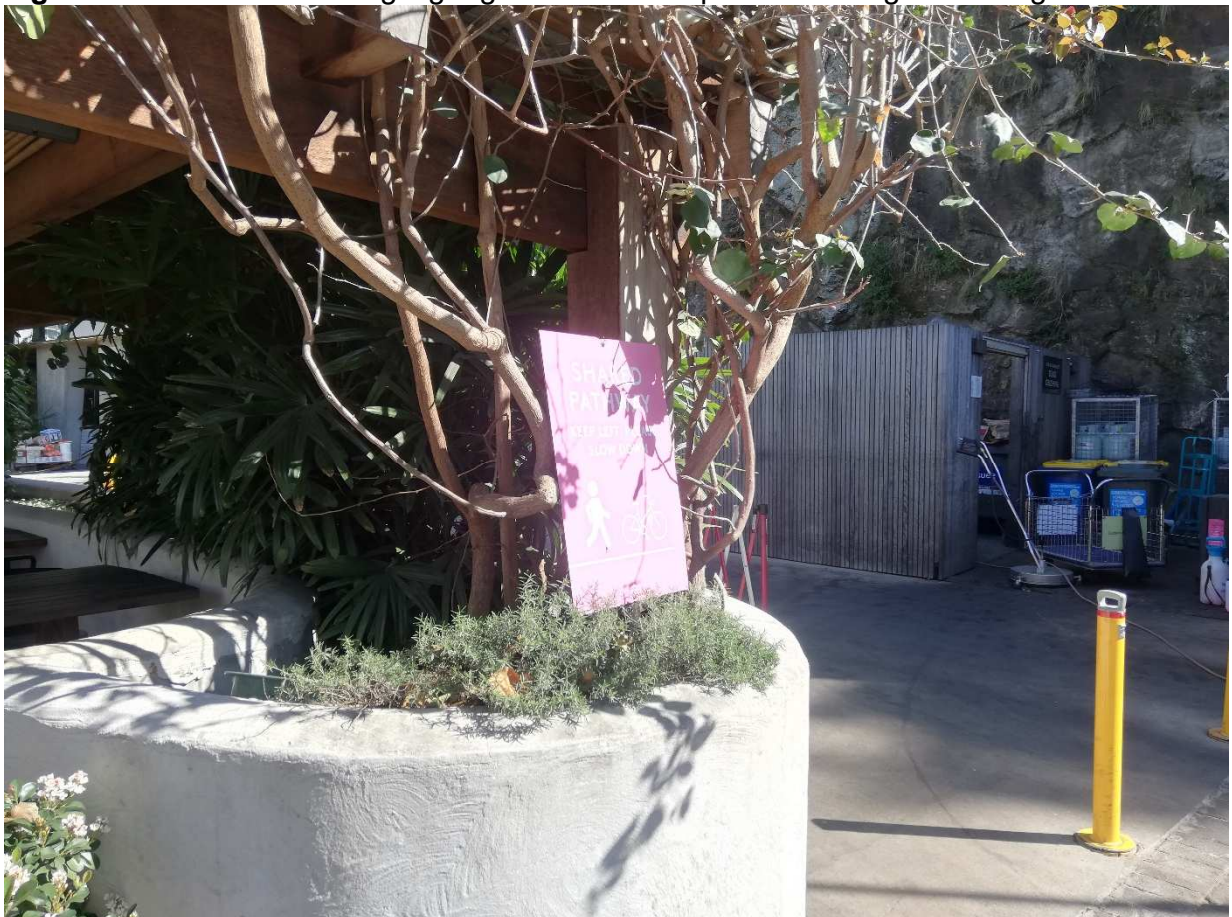
Once again, however, these fixes do not go far enough, and do not address the major issue with sight-lines between pedestrians and cyclists travelling east-bound along the path, and patrons exiting the beer garden. Council should insist on affirmative remediations for these sight-line issues, as they appear to have been caused by two significant deviations from the original landscaping plans:

The sight-line issues were already addressed as part of DA A005092838. In their response on 14 February 2019, Urbis acknowledged the issues, and recommended a number of remedies (such as warning signs for patrons exiting the beer garden, or trimming of foliage). However, none of these remedies appear to have ever been effectively implemented. The foliage does not appear to have ever been trimmed, and the warning signage installed is not actually visible to patrons exiting the beer garden. (Refer Figure 5 at the end of this submission)

Figure 5: Ineffective warning signage not visible to patrons exiting the beer garden

At this point, it seems that the most reasonable and effective solution would be to close that access/egress point to the beer garden, except for emergency egress. The viability of this closure has been demonstrated over the last two years, with the exit being closed for extended periods (due to COVID verification and record-keeping requirements), without any apparent ill-effects.

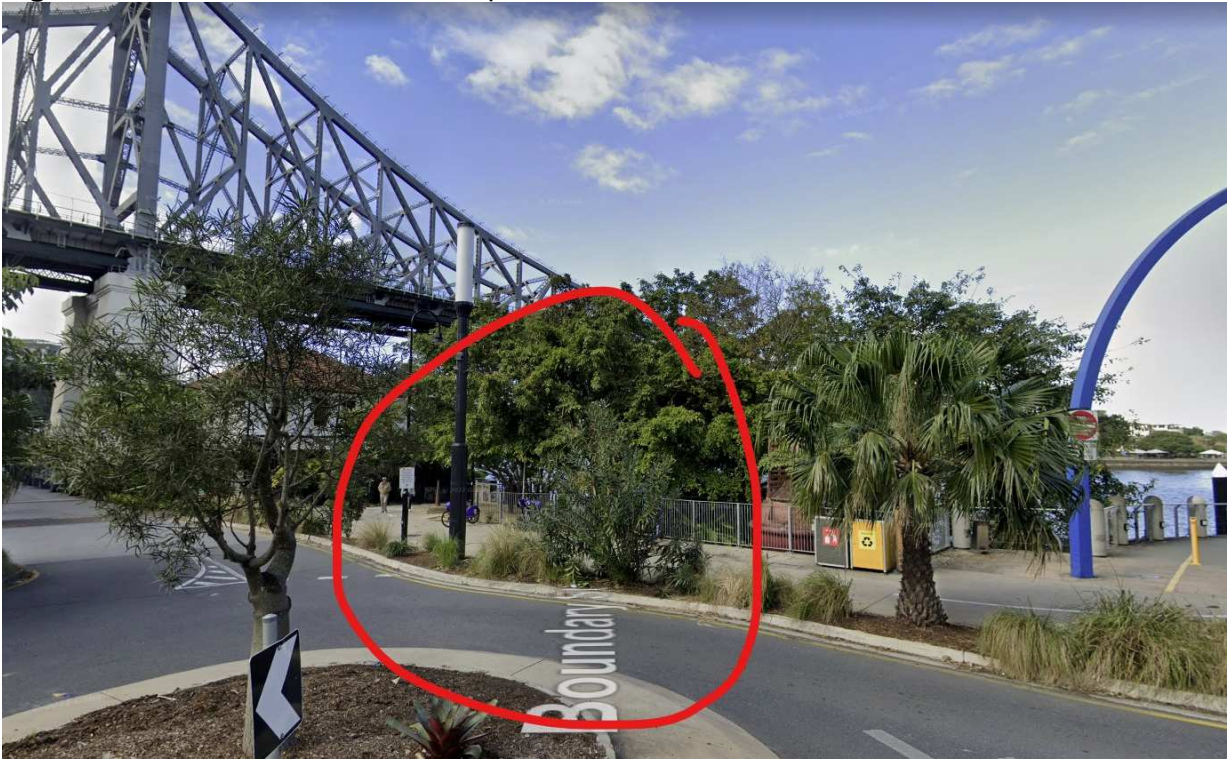
Of particular note, is the continued use of the poisonous Pink oleander plant near the roundabout (<https://www.childrens.health.qld.gov.au/poisonous-plant-pink-oleander-nerium-oleander/>). (Refer Figure 6 at the end of this submission) While reviewing plantings on the site, this should also be addressed.

Figure 6: Poisonous Pink oleander plant near roundabout
