## Brisbane Central Business District Bicycle User Group CBD BUG

I write to you on behalf of Brisbane Central Business District Bicycle User Group members to question the Howard Smith Wharves (HSW) redevelopment receiving 2020 Planning Institute of Australia awards in the categories of "Great Place Award" and "Hard Won Victory".

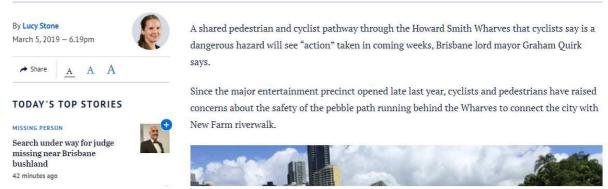
1. HSW constructed the main public easement (connecting to the New Farm Riverwalk) as an off-camber, loose gravel, shared path, which proved both hazardous to path users, and impossible to maintain (Figures 1,2,3). This path was finally replaced with a properly sealed surface in August 2019, after intense lobbying from active transport groups (Figure 4).

Figure 1: news article regarding hazardous pebble path

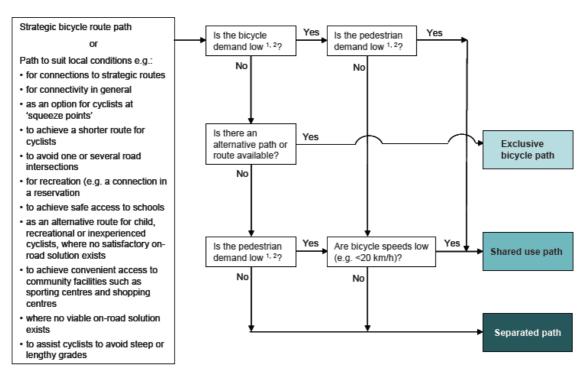
- 3. The CBD BUG understands that path failed to meet multiple aspects of the "AustRoads guide" and DDA legislation:
  - a. in relation to its selection as a shared, rather than separated path (Figure 5)
