File number:  
2020/2713  
Deceased name:  
Carolyn Anne Lister

### **Coroner's findings and notice of completion of coronial investigation**

Carolyn Anne Lister

On 30 June 2020, Carolyn died instantly as the result of a crash between her bicycle and a large tip truck, near the intersection of O'Connell Terrace and Bowen Bridge Road, opposite the RWBH at Herston, Brisbane in Queensland.

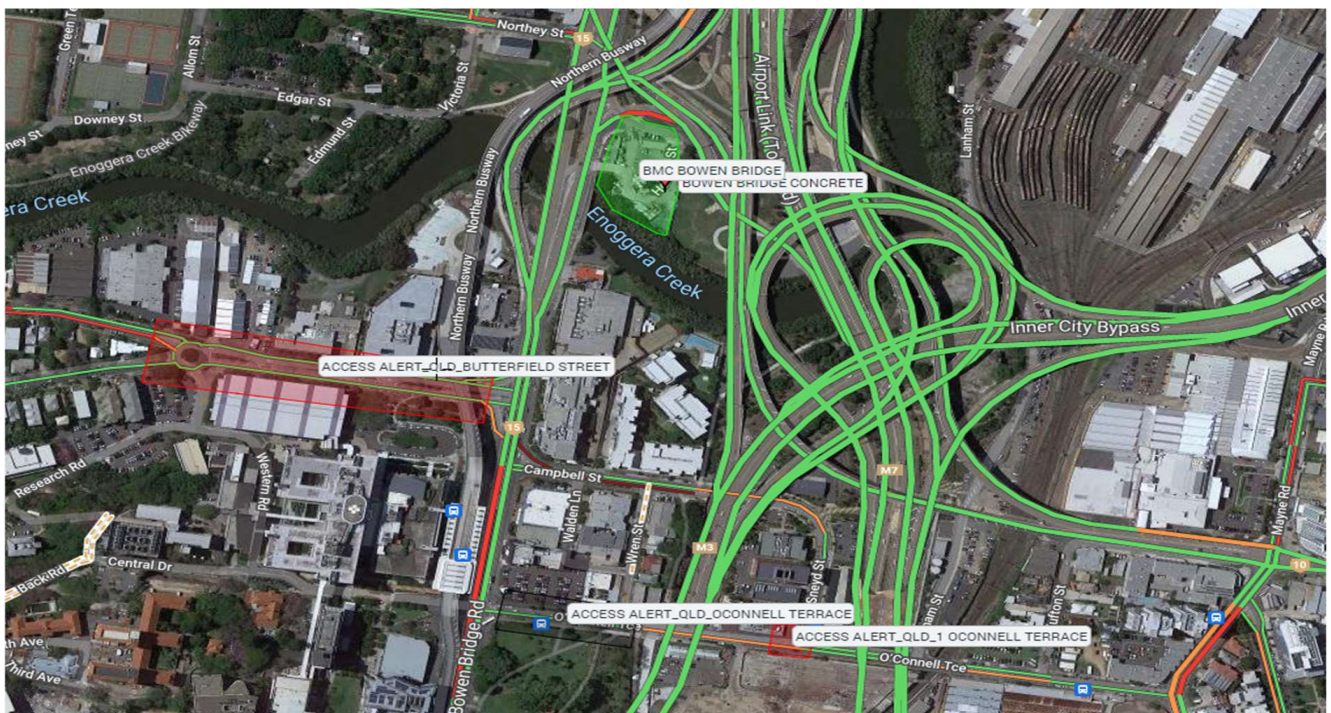
We also have applied geofence alerts on the 3 roads below that all our company and dedicated contractor fleets (fitted with Boral GPS tracking) triggers and alerts us by email if the fleet uses any of these 3 roads.
