Brisbane Central Business District Bicycle User Group CBD BUG

This letter is in relation to the inappropriate design of the new intersection of the Brisbane City Council off-road bikepath that runs north-south through Coorparoo where it crosses Morley Street.

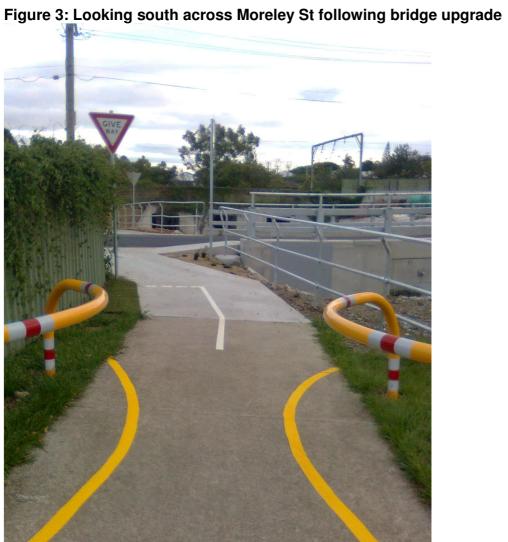
- By its close proximity to the bikepath entrance the eastern ramp from the new bridge's north side pedestrian path to the ground level now creates a hazard for cyclists entering/exiting the bikepath who are not aware and / or who do not realise this ramp is in this position. This ramp is viewed as particularly hazardous for cyclists riding north across Morley Street as they are likely to run into the vertical side of this ramp in mistakenly assuming that the path goes straight across the road on the line of the visible path as it did prior to this new bridge being installed. This is most clearly evident from the attached Figure 2.
